VERY FAST BEAM LOSSES AT HERA, AND WHAT HAS BEEN DONE ABOUT IT

M. Werner and K. Wittenburg, DESY, Hamburg, Germany

Talk given at the 39th ICFA Advanced Beam Dynamics Workshop,
“High Intensity High Brightness Hadron Beams, HB2006”,
held at the EPOCHAL International Congress Center in Tsukuba City, Japan, May 29-June 2, 2006.

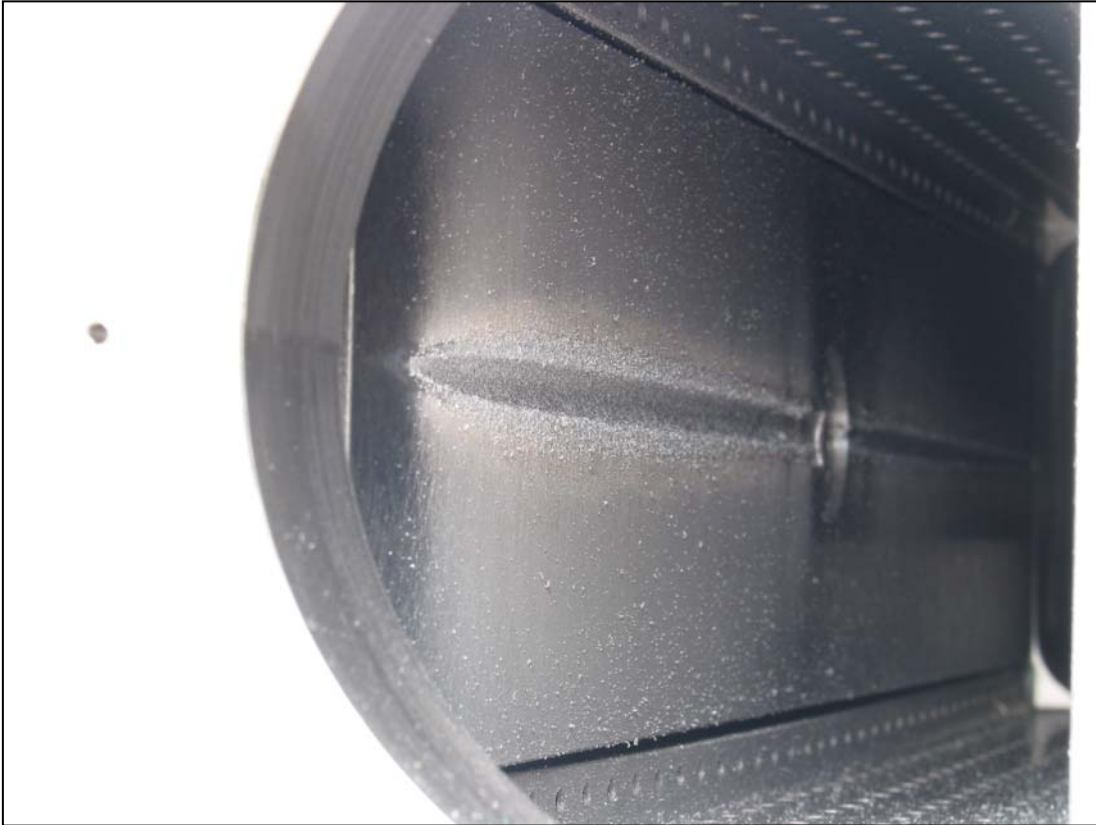
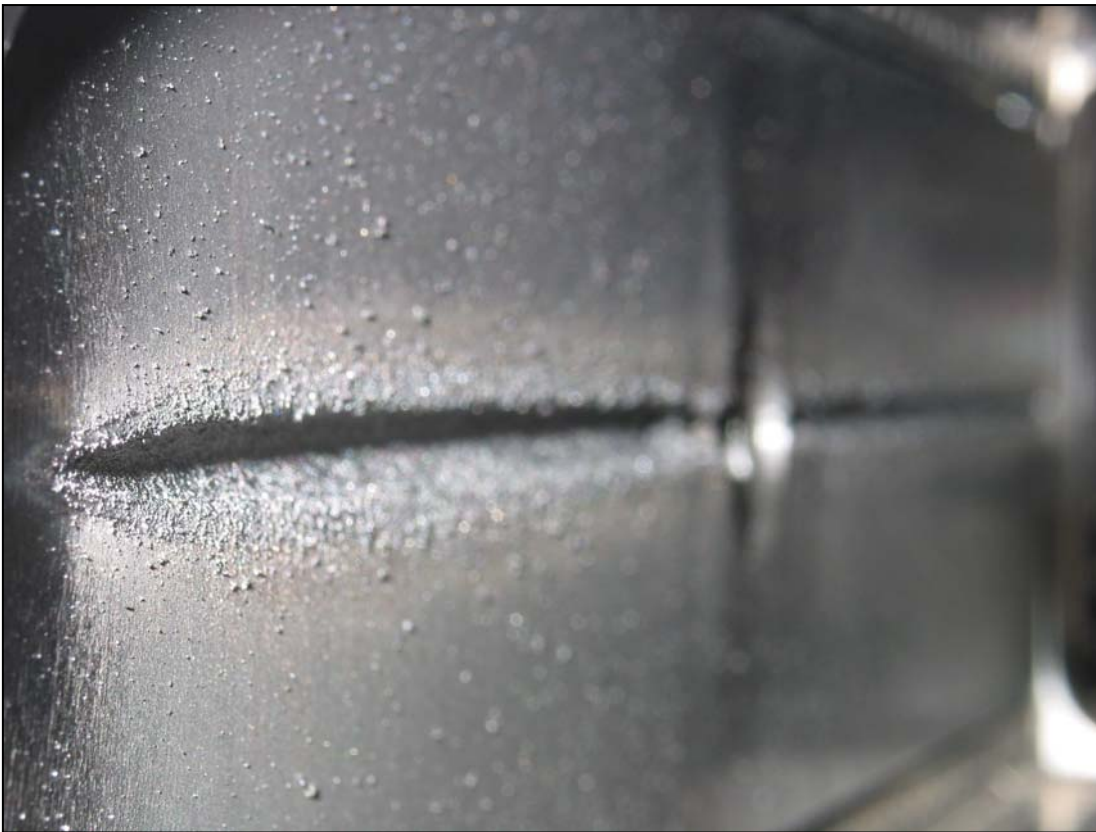
The following pictures 2 and 3 show a 5mm groove in the HERA proton beam collimator. The pictures were taken in 2003 when the collimators were inspected. The machine was probably running with these collimators for some years. Note that a specific accident resulting in this damage could not be identified! The damage could be a result of many years of operation as well as a result of a few intensive unintended beam losses.

Fig 2, 3: 5 mm groove in the HERA proton collimator detected in 2003 after many years of operation. Courtesy of Mike Seidel, DESY.
